Design of Highway Bridges

An LRFD Approach

Fourth Edition

Richard M. Barker
Jay A. Puckett

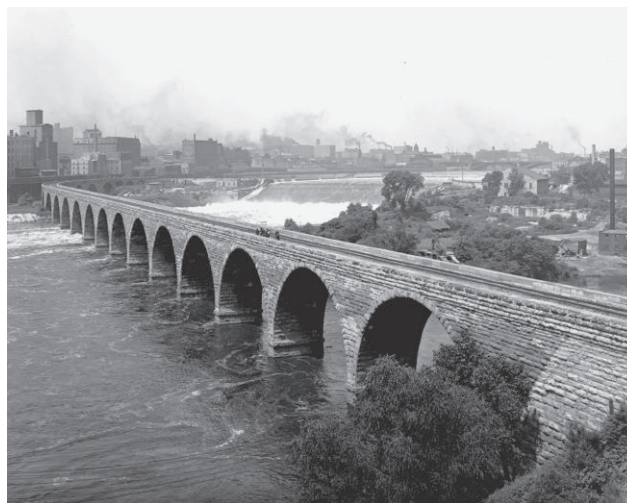
Fig. 1.1 James J. Hill Stone Arch Bridge, Minneapolis, Minnesota. (Hibbard Photo, Minnesota Historical Society, July 1905.)

The James J. Hill Stone Arch Bridge (Fig. 1.1) is 2490 ft (760 m) long and incorporated 23 arches in its original design (later, 2 arches were replaced with steel trusses to provide navigational clearance). The structure carried Hill's Great Northern Railroad (now merged into the Burlington Northern Santa Fe Railway) across the Mississippi River just below St. Anthony Falls. It played a key role in the development of the Northwest. The bridge was retired in 1982, just short of its 100th birthday, but it still stands today as a reminder of an era gone by and bridges that were built to last (Jackson, 1988).

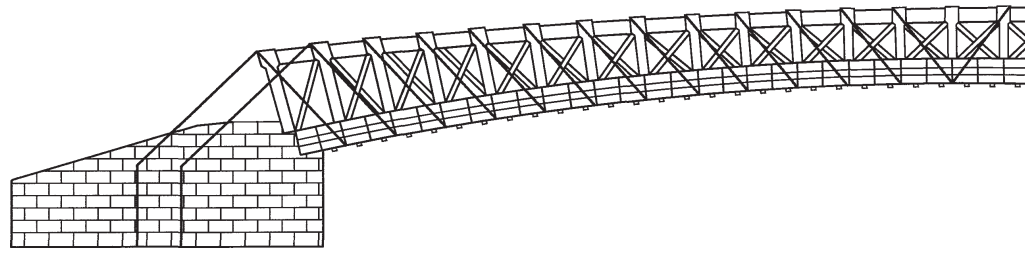
Fig. 1.2 Trussed arch—designed by Lewis Wernwag, patented 1812.

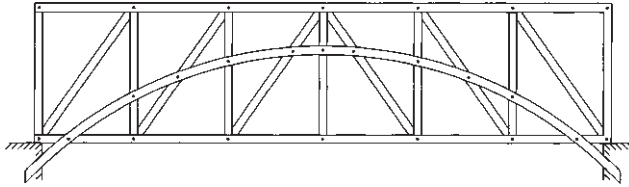
Fig. 1.3 Arched truss—designed by Theodore Burr, patented 1817. (From *Bridges and Men* by Joseph Gies. Copyright © 1963 by Joseph Gies. Used by permission of Doubleday, a division of Bantam Doubleday Dell Publishing Group, Inc.)

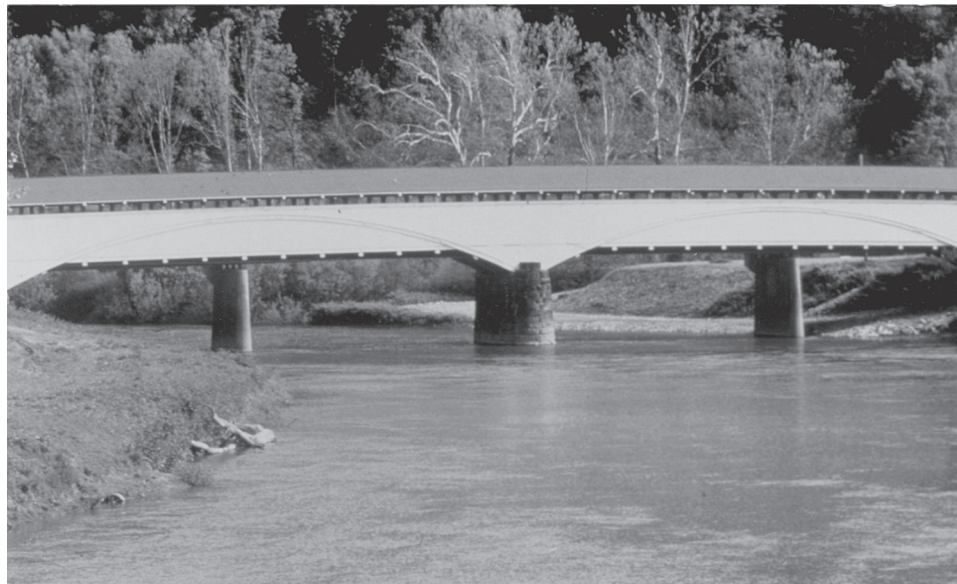
Fig. 1.4 Philippi covered bridge. (Photo by Larry Belcher, courtesy of West Virginia Department of Transportation.)

In contrast to the trussed arch of Palmer and Wernwag, Burr utilized an arched truss in which a truss is reinforced by an arch (Fig. 1.3) and patented his design in 1817. An example of one that has survived until today is the Philippi Covered Bridge (Fig. 1.4) across the Tygant's Valley River, West Virginia. Lemuel Chenoweth completed it in 1852 as a two-span Burr arched truss with a total length of 577 ft (176 m) long. In later years, two reinforced concrete piers were added under each span to strengthen the bridge (Exhibit 3 in the color insert). As a result, it is able to carry traffic loads and is the nation's only covered bridge serving a federal highway.

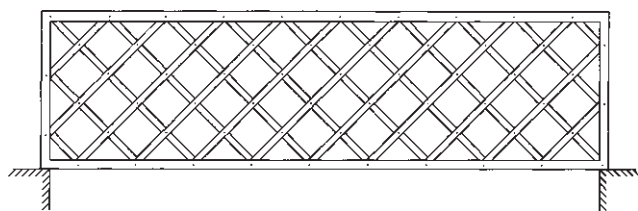
Fig. 1.5 Lattice truss—designed by Ithiel Town, patented 1820. (From *Bridges and Men* by Joseph Gies. Copyright © 1963 by Joseph Gies. Used by permission of Doubleday, a division of Bantam Doubleday Dell Publishing Group, Inc.)

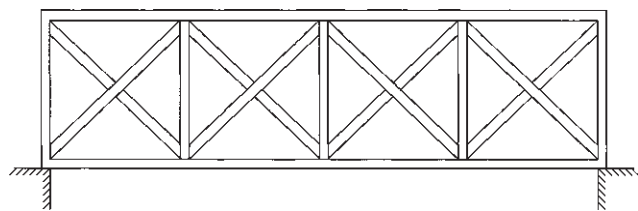
Fig. 1.6 Multiple king-post truss—designed by Colonel Stephen H. Long in 1829. (From *Bridges and Men* by Joseph Gies. Copyright © 1963 by Joseph Gies. Used by permission of Doubleday, a division of Bantam Doubleday Dell Publishing Group, Inc.)

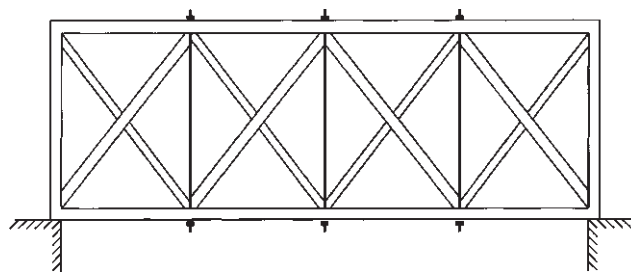
Fig. 1.7 Howe truss—designed by William Howe, patented in 1841. (From *Bridges and Men* by Joseph Gies. Copyright © 1963 by Joseph Gies. Used by permission of Doubleday, a division of Bantam Doubleday Dell Publishing Group, Inc.)

In 1841, William Howe, uncle of Elias Howe, the inventor of the sewing machine, received a patent on a truss arrangement in which he took Long's panel system and replaced the wooden vertical members with wrought-iron rods (Gies, 1963). The metal rods ran through the top and bottom chords and could be tightened by turnbuckles to hold the wooden diagonal web members in compression against cast-iron angle blocks (Fig. 1.7). Occasionally, Howe truss bridges were built entirely of metal, but in general they were composed of both wood and metal components. These bridges have the advantages of the panel system as well as those offered by counterbracing.

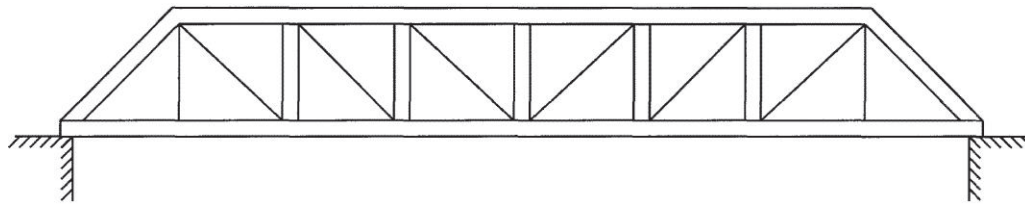
Fig. 1.8 Pratt truss—designed by Thomas and Caleb Pratt, patented in 1844. (From *Bridges and Men* by Joseph Gies. Copyright © 1963 by Joseph Gies. Used by permission of Doubleday, a division of Bantam Doubleday Dell Publishing Group, Inc.)

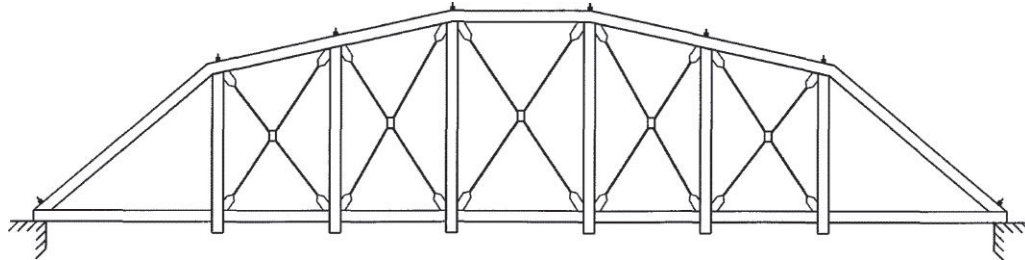
Fig. 1.9 Bowstring arch—designed by Squire Whipple, patented in 1841.

Arch bridges are aesthetically pleasing and can be economically competitive with other bridge types. Sometimes the arch can be above the deck, as in a tied-arch design, or as in the bowstring arch of Whipple (Fig. 1.9). Other times, when the foundation materials can resist the thrusts, the arch is below the deck. Restraint conditions at the supports of an arch can be fixed or hinged. And if a designer chooses, a third hinge can be placed at the crown to make the arch statically determinate or nonredundant.

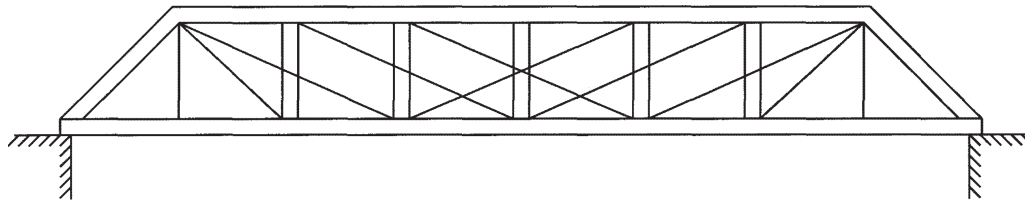
Fig. 1.10 Double-intersection Pratt—credited to Squire Whipple.

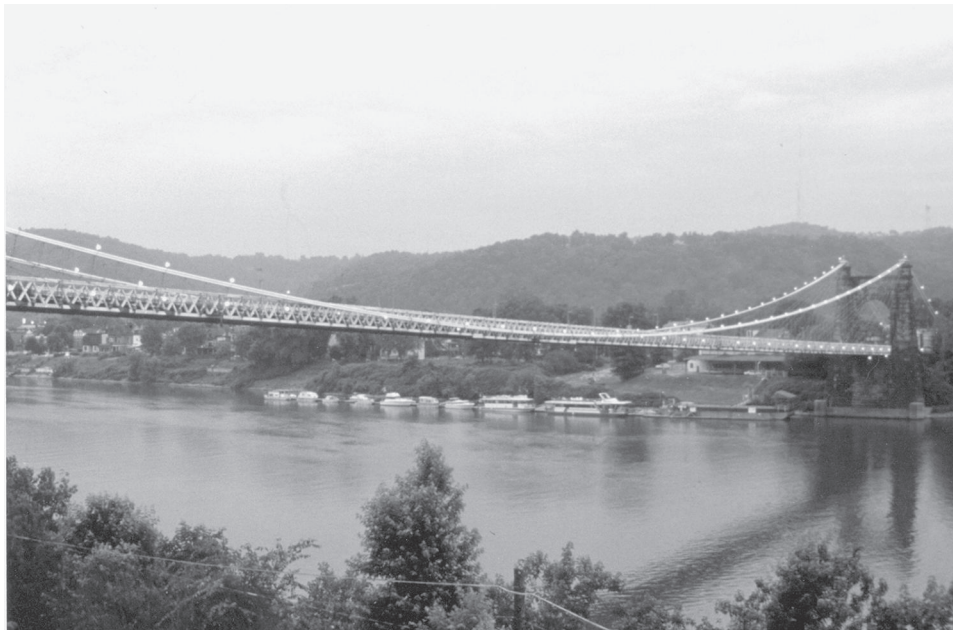
Fig. 1.11 Wheeling Suspension Bridge. (Photo by John Brunell, courtesy of West Virginia Department of Transportation.)

The original Wheeling Suspension Bridge did not have the stiffening truss shown in Figure 1.11. This truss was added after a windstorm in 1854 caused the bridge to swing back and forth with increased momentum, the deck to twist and undulate in waves nearly as high as the towers, until it all came crashing down into the river (very similar to the Tacoma Narrows Bridge failure some 80 years later). A Web search for “Tacoma Narrows Movie” will provide several opportunities to view movies that illustrate the failure.

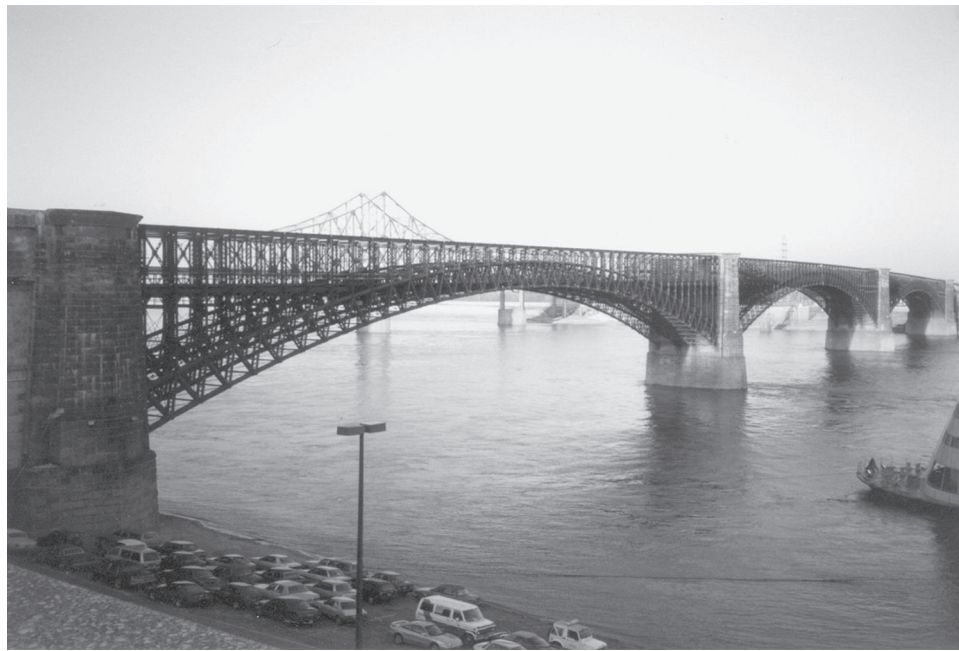
Fig. 1.12 Eads Bridge, St. Louis, Missouri. (Photo courtesy of Kathryn Kontrim, 1996.)

One of the most significant bridges built in the United States is the steel deck arch bridge designed by James B. Eads (Exhibit 6 in the color insert) across the Mississippi River at St. Louis. It took 7 years to construct and was completed in 1874. The three-arch superstructure consisted of two 502 ft (153 m) side arches and one 520 ft (159 m) center arch that carried two decks of railroad and highway traffic (Fig. 1.12). The Eads Bridge is significant because of the very deep pneumatic caissons for the foundations, the early use of steel in the design, and the graceful beauty of its huge arches as they span across the wide river (Jackson, 1988).

Because of his previous experience as a salvage diver, Eads realized that the foundations of his bridge could not be placed on the shifting sands of the riverbed but must be set on bedrock. The west abutment was built first with the aid of a cofferdam and founded on bedrock at a depth of 47 ft (14 m). Site data indicated that bedrock sloped downward from west to east, with an unknown depth of over 100 ft (30 m) at the east abutment, presenting a real problem for cofferdams. While recuperating from an illness in France, Eads learned that European engineers had used compressed air to keep water out of closed caissons (Gies, 1963). He adapted the technique of using caissons, or wooden boxes; added a few innovations of his own, such as a sand pump; and completed the west and east piers in the river. The west pier is at a depth of 86 ft (26 m) and the east pier at a depth of 94 ft (29 m).

The cantilever construction of the arches for the Eads Bridge was also a significant engineering milestone. Falsework in the river was not possible, so Eads built falsework on top of the piers and cantilevered the arches, segment by segment in a balanced manner, until the arch halves met at midspan (Kirby et al., 1956). On May 24, 1874, the highway deck was opened for pedestrians; on June 3 it was opened for vehicles; and on July 2 some 14 locomotives, 7 on each track, crossed side by side (Gies, 1963). The biggest bridge of any type ever built anywhere up to that time had been completed. The Eads Bridge remains in service today and at the time of this writing is being rehabilitated to repair the track, ties, and rails, the deck and floor system, masonry, and other structural improvements.

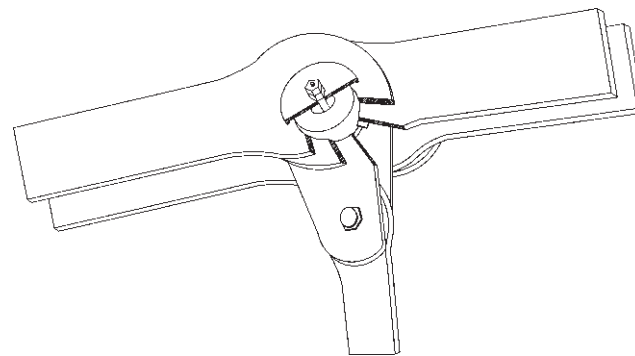
Fig. 2.1 Typical detail of eyebar chain and hanger connection (NTSB, 1970).

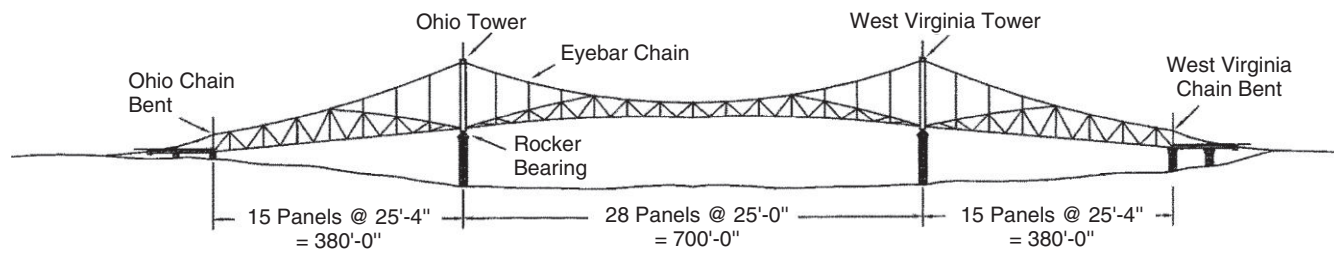
Fig. 2.2 Elevation of Silver Bridge over Ohio River, Point Pleasant, West Virginia (NTSB, 1970).

Two other features of the design were also unique (Dicker, 1971): The eyebar chains were the top chord of the stiffening truss over a portion of all three spans, and the base of each tower rested on rocker bearings (Fig. 2.2). As a result, redundant load paths did not exist, and the failure of a link in the eyebar chain would initiate rapid progressive failure of the entire bridge.

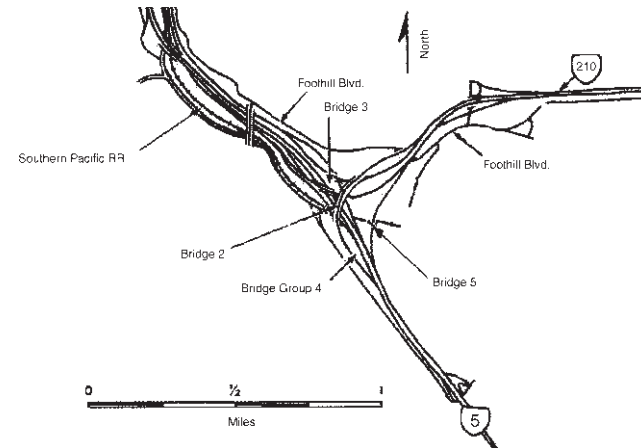
Fig. 2.3 Layout of the I-5 and I-210 Interchange (Lew et al., 1971).

Description Bridge types in this interchange included composite steel girders, precast prestressed I-beam girders, and prestressed and nonprestressed cast-in-place reinforced concrete box girder bridges. The South Connector Overcrossing structure (bridge 2, Fig. 2.3) was a seven-span, curved, nonprestressed reinforced concrete box girder, carried on single-column bents, with a maximum span of 129 ft (39 m). The North Connector Overcrossing structure (bridge 3, Fig. 2.3) was a skewed four-span, curved, nonprestressed reinforced concrete box girder, carried on multiple-column bents, with a maximum span of 180 ft (55 m). A group of parallel composite steel girder bridges (bridge group 4,

Fig. 2.3) carried I-5 North and I-5 South over the Southern Pacific railroad tracks and San Fernando Road. Immediately to the east of this group, over the same tracks and road, was a two-span cast-in-place prestressed concrete box girder (bridge 5, Fig. 2.3) that was carried on a single bent, with a maximum span of 122 ft (37 m).

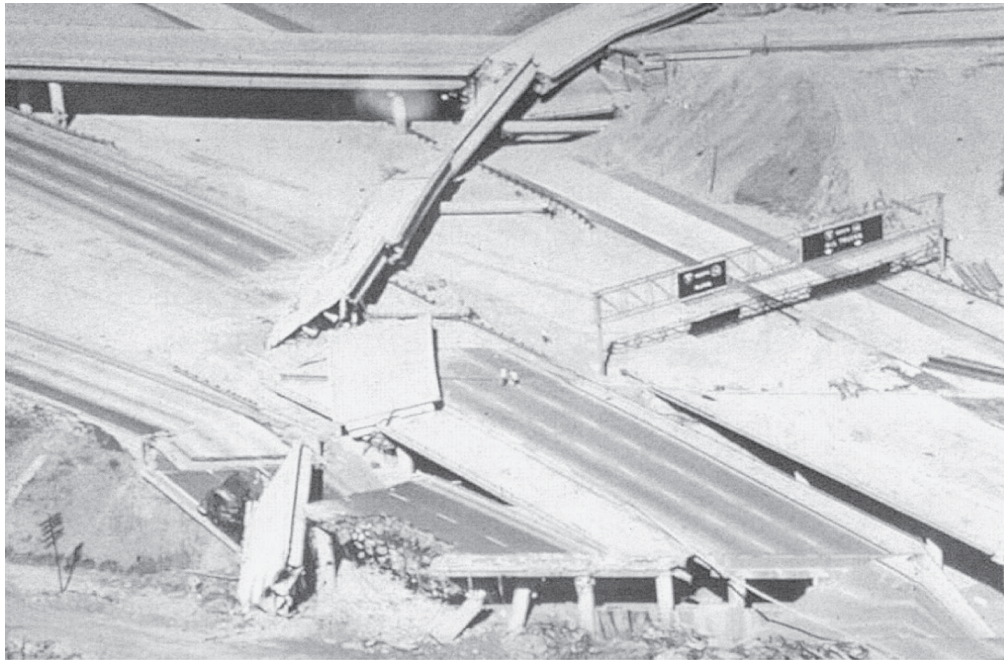
Fig. 2.4 View looking north at the I-5 and I-210 interchange after the quake showing the collapsed South Connector Overcrossing structure (bridge 2) in the center, the North Connector Overcrossing structure (bridge 3) at the top, and bridge group 4 at the bottom. (Photo courtesy E. V. Leyendecker, U.S. Geological Survey.)

Cause of Collapse More than one cause contributed to the collapse of the bridges at the I-5 and I-210 interchange. The bridges were designed for lateral seismic forces of about 4% of the dead load, which is equivalent to an acceleration of 0.04 g, and vertical seismic forces were not considered. From field measurements made during the earthquake, the estimated ground accelerations at the interchange were from 0.33 g to 0.50 g laterally and from 0.17 g to 0.25 g vertically. The seismic forces were larger than what the structures

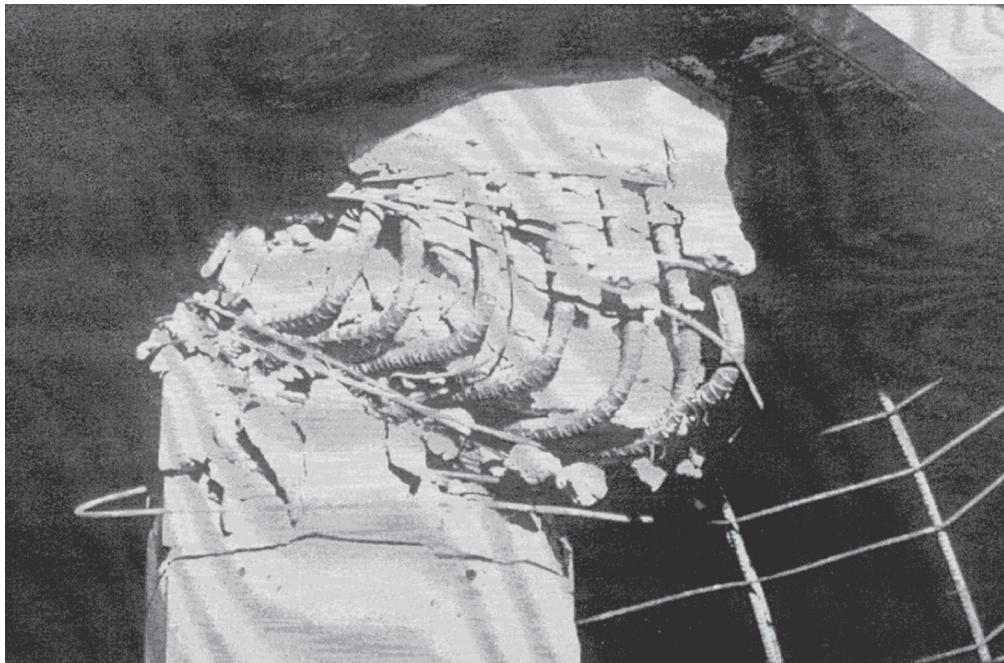
Fig. 2.5 Close-up of exterior spiral column in bent 2 of bridge 3. (Photo courtesy E. V. Leyendecker, U.S. Geological Survey.)

were designed for and placed an energy demand on the structures that could not be dissipated in the column–girder and column–footing connections. The connections failed, resulting in displacements that produced large secondary effects, which led to progressive collapse. Girders fell off their supports because the seat dimensions were smaller than the earthquake displacements. These displacement effects were amplified in the bridges that were curved or skewed and were greater in spread footings than in pile-supported foundations.

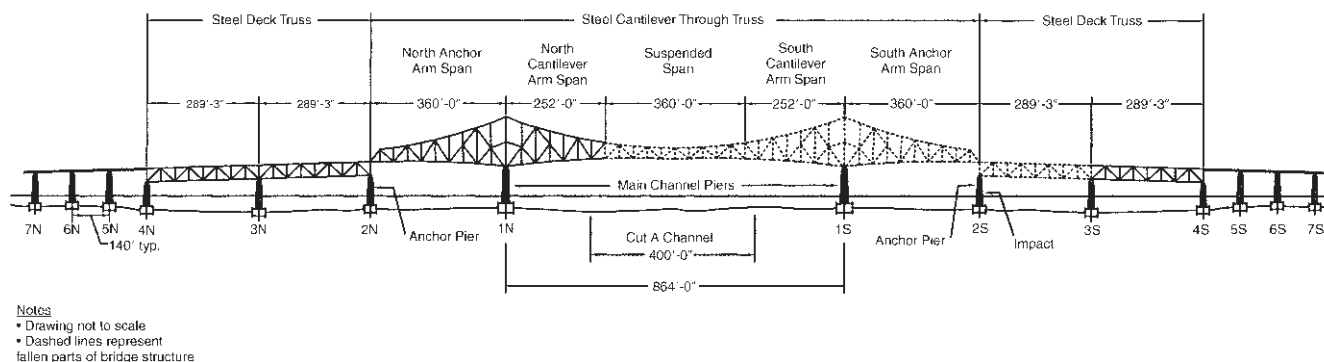
Fig. 2.6 Diagram of the damaged Sunshine Skyway Bridge (looking eastward). (NTSB, 1981).

Cause of Collapse The NTSB determined that the probable cause of the accident was the failure of the pilot of the *Summit Venture* to abort the passage under the bridge when the navigational references for the channel and bridge were lost in the heavy rain and high winds of an intense thunderstorm (NTSB, 1981). The lack of a structural pier protection system, which could have redirected the vessel and reduced the amount of damage, contributed to the loss of life. The collapse of the cantilever through truss and deck truss spans of the Sunshine Skyway Bridge was due to the loss of support of the pier rammed by the *Summit*

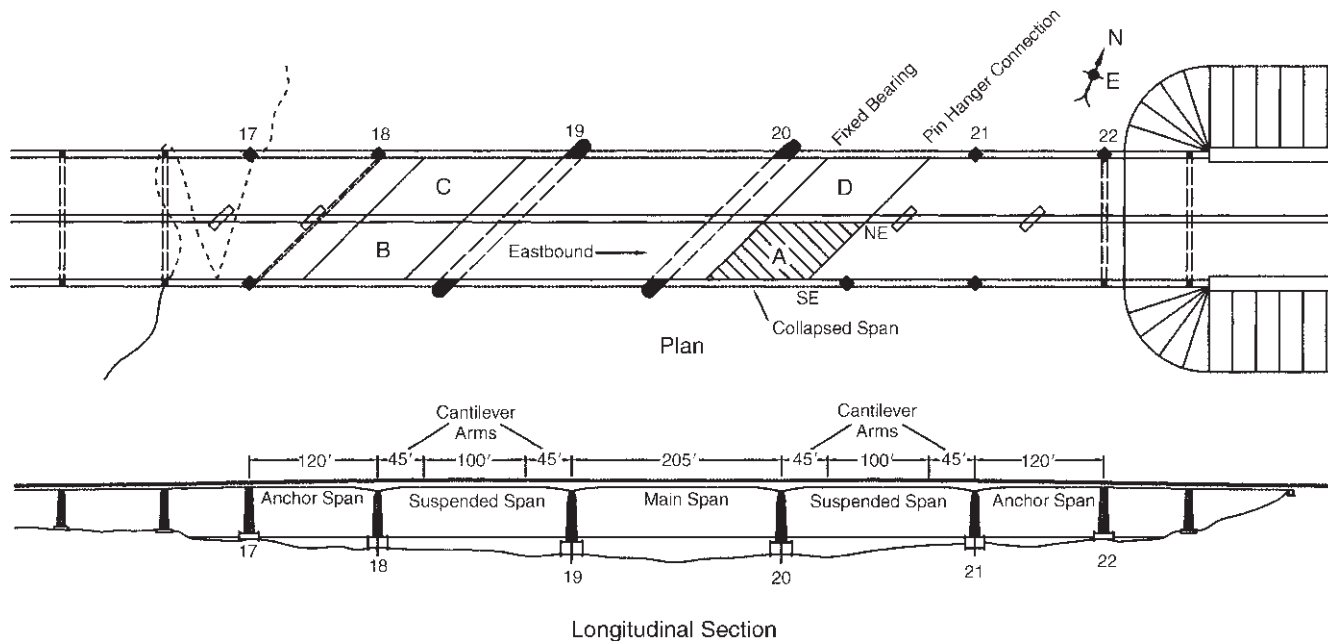
Fig. 2.7 Plan view (top) and longitudinal view (bottom) of the Mianus River Bridge. (Note that the skew of piers 17 through 22 is not depicted in the longitudinal view). (NTSB, 1984).

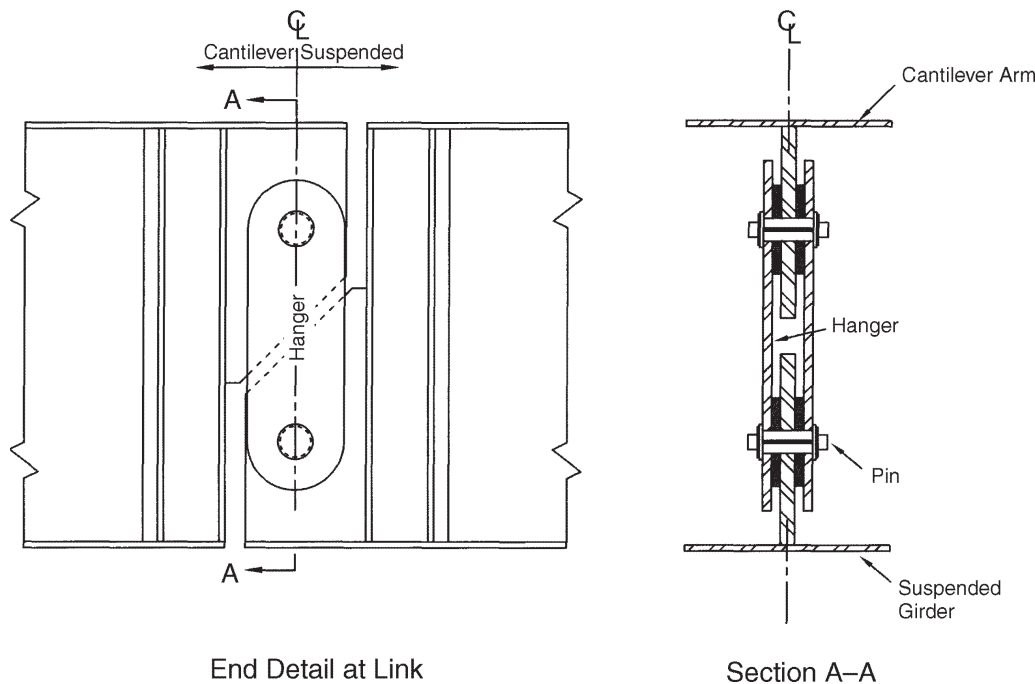
Fig. 2.8 Schematic of pin-and-hanger assembly of the Mianus River Bridge. (NTSB, 1984).

After the 1967 collapse of the Silver Bridge, the National Bridge Inspection Standards were established, which required regular inspections of bridges at intervals not exceeding 2 years. ConnDOT's Bridge Safety and Inspection Section had inspected the Mianus River Bridge 12 times since 1967 with the last inspection in 1982. The pin-and-hanger assemblies of the inside girders were observed from a catwalk between the separated roadways, but the pin-and-hanger assemblies connecting the outside

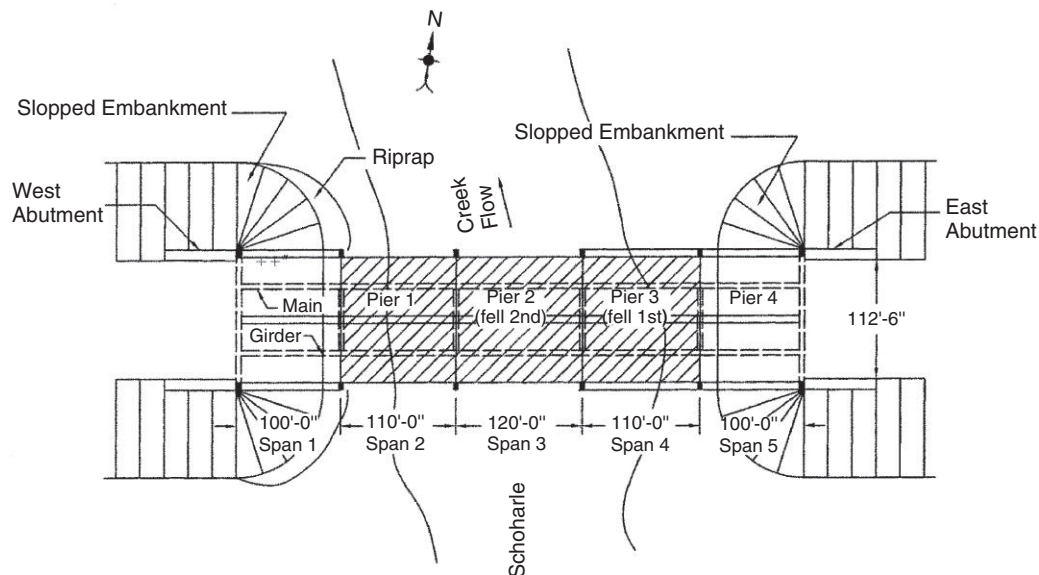
Fig. 2.9 Schematic plan of Schoharie Creek Bridge. (NTSB, 1988).

The NTSB determined that the probable cause of the collapse of the Schoharie Creek Bridge was the failure of the New York State Thruway Authority to maintain adequate riprap around the bridge piers, which led to the severe erosion of soil beneath the spread footings (NTSB, 1988). Contributing to the severity of the accident was the lack of structural redundancy in the bridge.

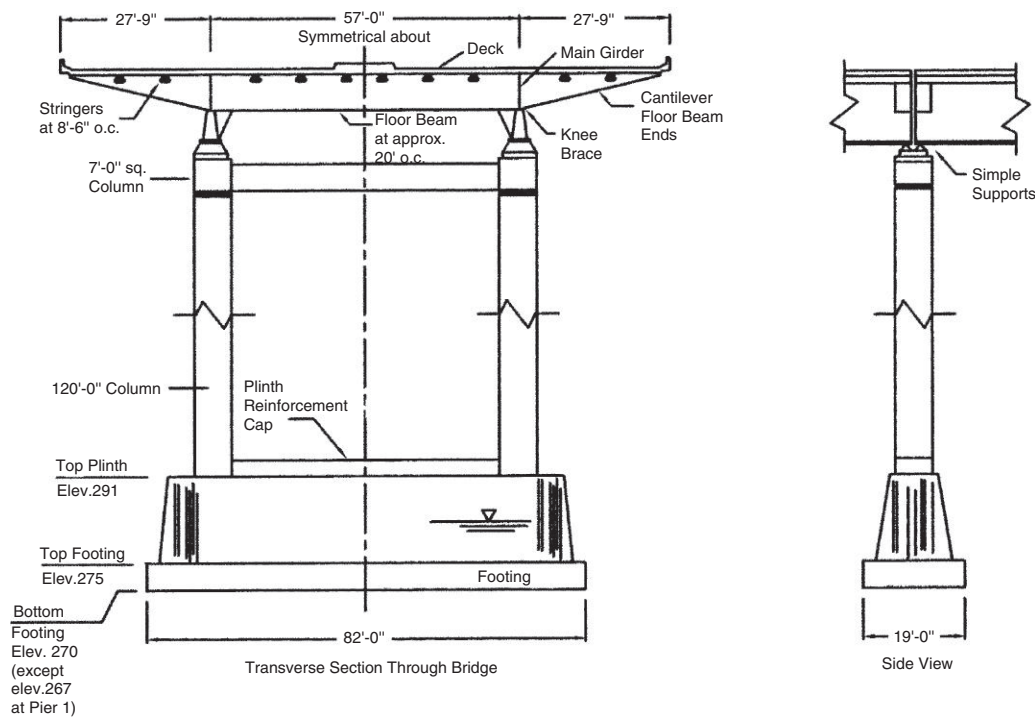
Fig. 2.10 Sections showing the Schoharie Creek Bridge pier supported on a spread footing. (NTSB, 1988).

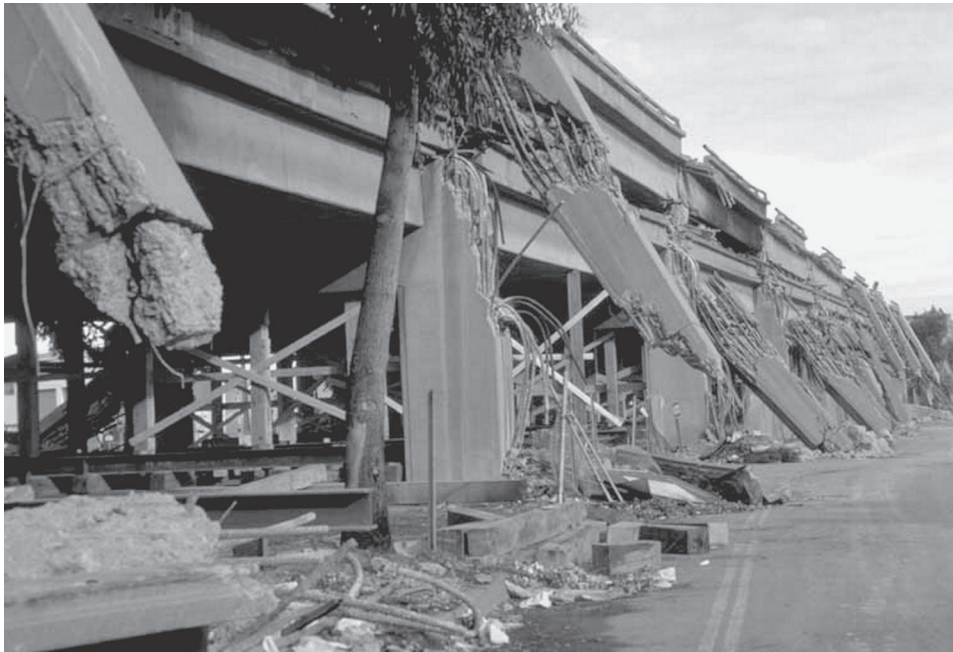
Fig. 2.11 Cypress Viaduct. (Photo courtesy H. G. Wilshire, U.S. Geological Survey.)

Description The 1989 Loma Prieta earthquake that occurred on October 17 resulted in over \$8 billion in damage and loss of 62 lives. Figure 2.11 illustrates the Cypress

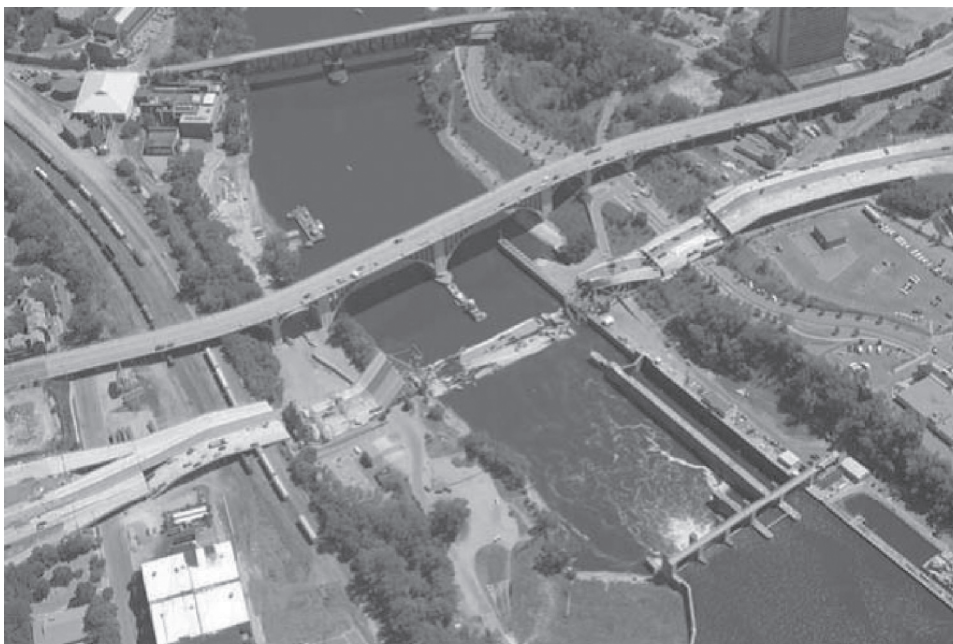
Fig. 2.12 Aerial view of I-35W Bridge after collapse. (NTSB, 2008).

Highway Bridge over the Mississippi River in Minneapolis, Minnesota, experienced a catastrophic failure in the main truss span of the deck truss. As a result, 1000 ft (305 m) of the deck truss collapsed, with about 456 ft (140 m) of the main span falling 108 ft (33 m) into the 15 ft (4.6 m) deep river (Fig. 2.12). A total of 111 vehicles were on the portion of the bridge that collapsed. As a result of the bridge collapse, 13 people died, and 145 were injured (NTSB, 2008).

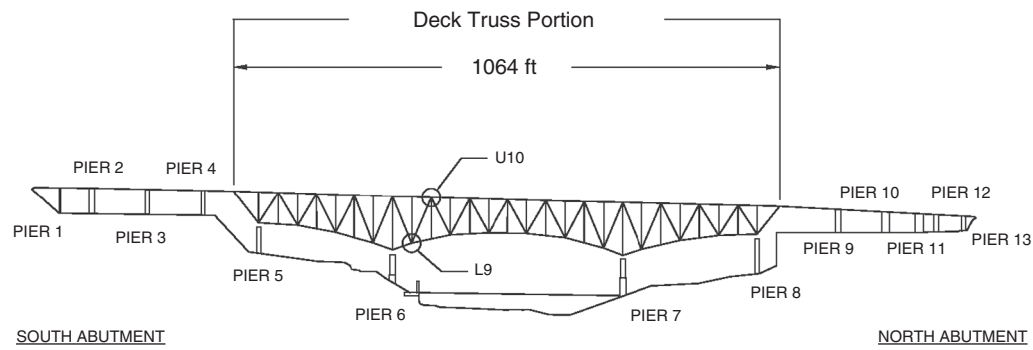
Fig. 2.13 East elevation of I-35W bridge. The deck truss portion of the bridge extends from just south of pier 5 to just north of pier 8. (NTSB, 2008).

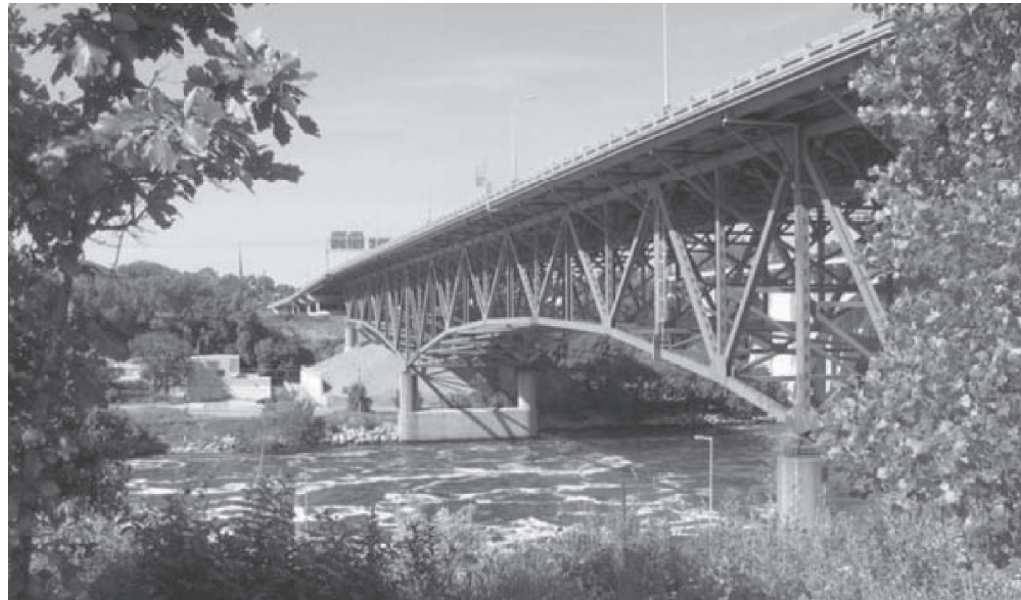
Fig. 2.14 Center span of I-35W bridge looking northeast. The center span is supported by pier 6 on the near (south) riverbank and pier 7 on the far (north) riverbank. (NTSB, 2008).

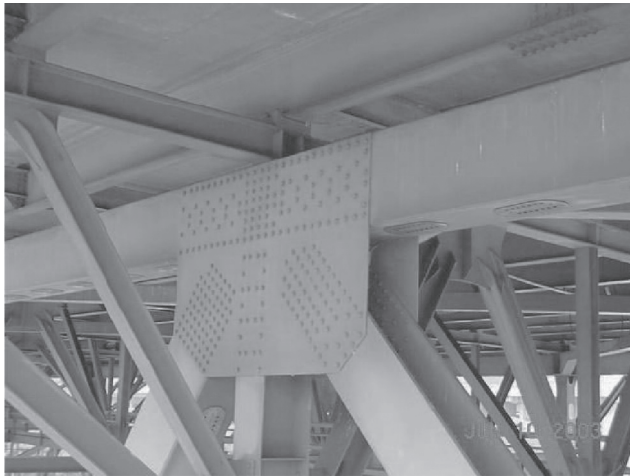
Fig. 2.15 Typical five-member node (two upper chord members, one vertical member, and two diagonal members) on I-35W Bridge. (NTSB, 2008).

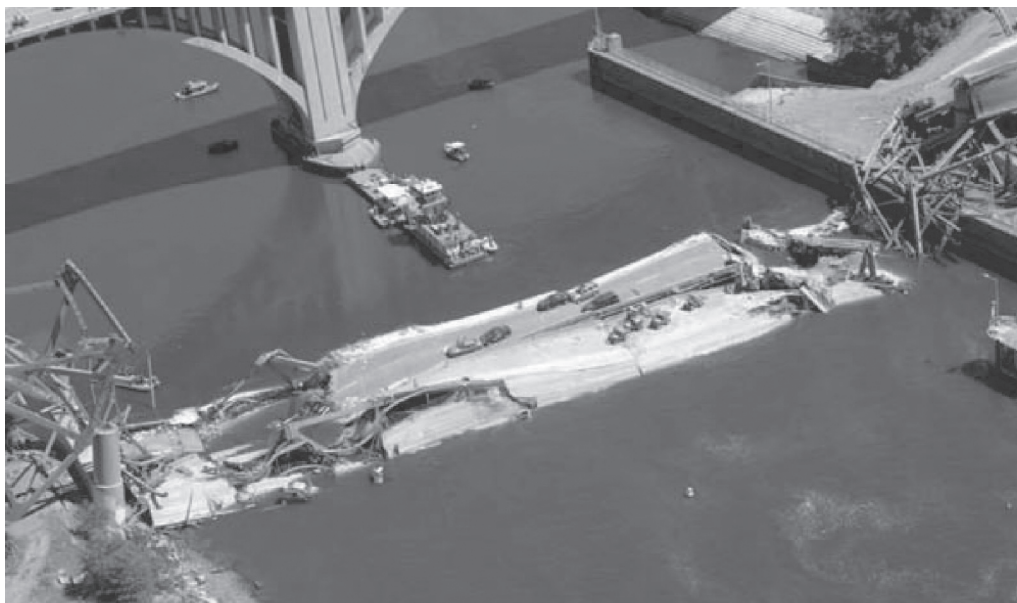
Fig. 2.16 Collapsed bridge center section, looking southeast. (NTSB, 2008).

Because much of the bridge center span collapsed, its structural components did not receive detailed inspection until after their removal. The recovered truss portions were laid out relative to their original positions at a nearby park. A gusset plate fracture pattern reconstructed from the pieces at node U10W (west side) is shown in Fig. 2.17. The curved line indicates the fracture, which was similar for both trusses. The diagonal and chords were separated from the remaining

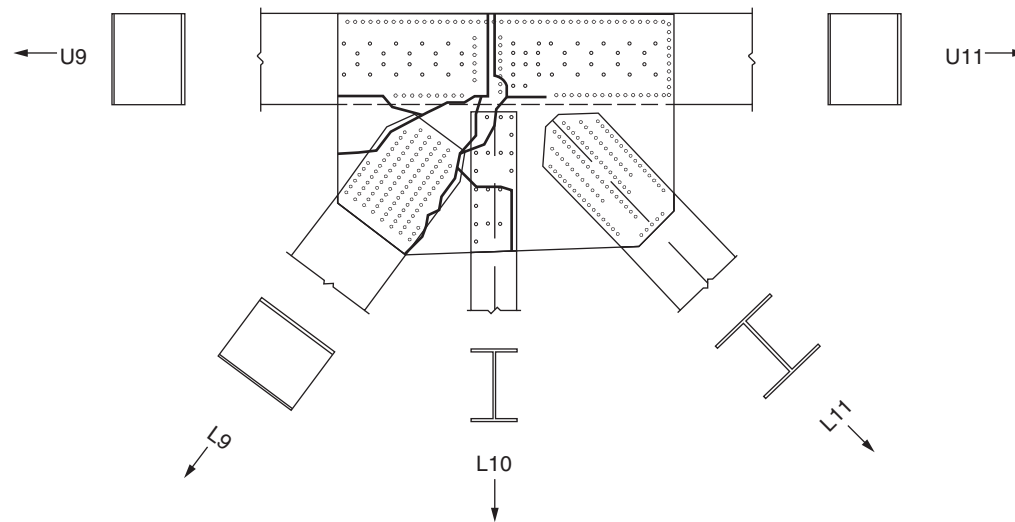
Fig. 2.17 Fracture pattern of outside (west) gusset plate at U10W. (NTSB, 2008).

members in the node. The remaining portion of the gusset plates kept the vertical and other diagonal connected.

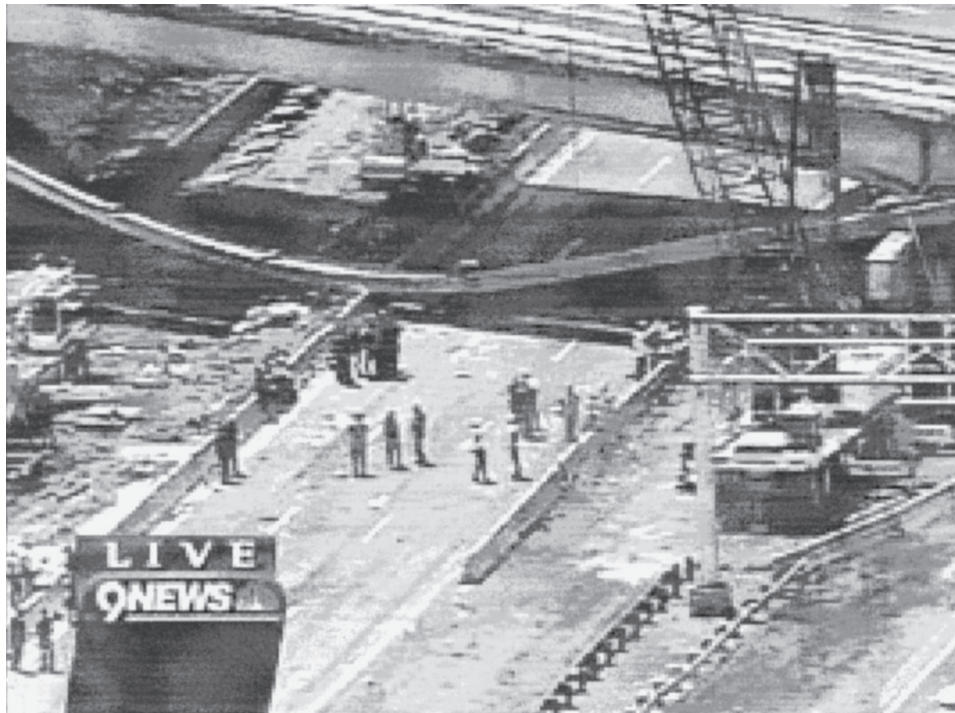
Fig. 2.18 Bridge failure near Golden, Colorado. (Photo from Golden Fire Department Annual Report 2004, Golden, Colorado. <http://ci.golden.co.us/files/2004fdreport.pdf>.)
